2 JULY 2004 DOĞUBAYAZIT (KARAKOSE-AĞRI) EARTHQUAKE

D. Kalafat, Y. Güneş, K. Kekovalı
B.U. Kandilli Observatory & ERI, National Earthquake Monitoring Centre
34684 Cengelkoy-İstanbul/TURKEY

Introduction

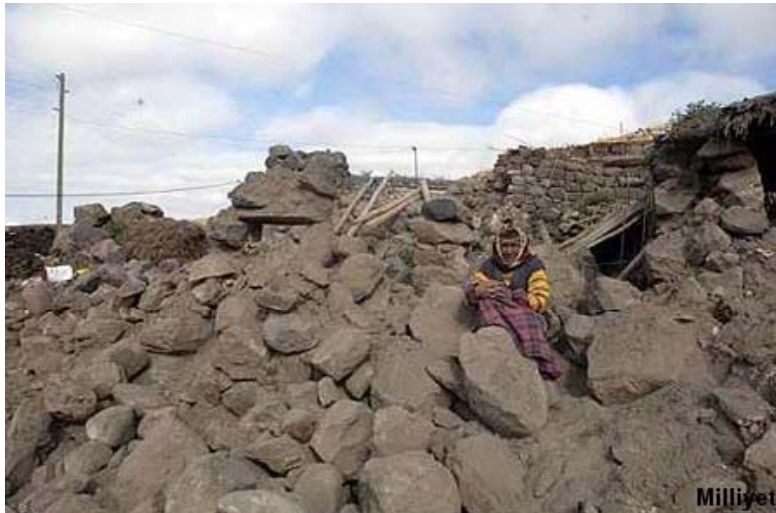
The epicentral area was reported 22 kilometers north-northwest of the district of Doğubayazıt, measuring 5.1 on the Richter scale by Kandilli Observatory National Earthquake Monitoring Center. The reason for the serious damage and casualties was that the buildings in the village were soil-roof and jerrybuilt.

Widespread damaged himis buildings in Yığınçal Village

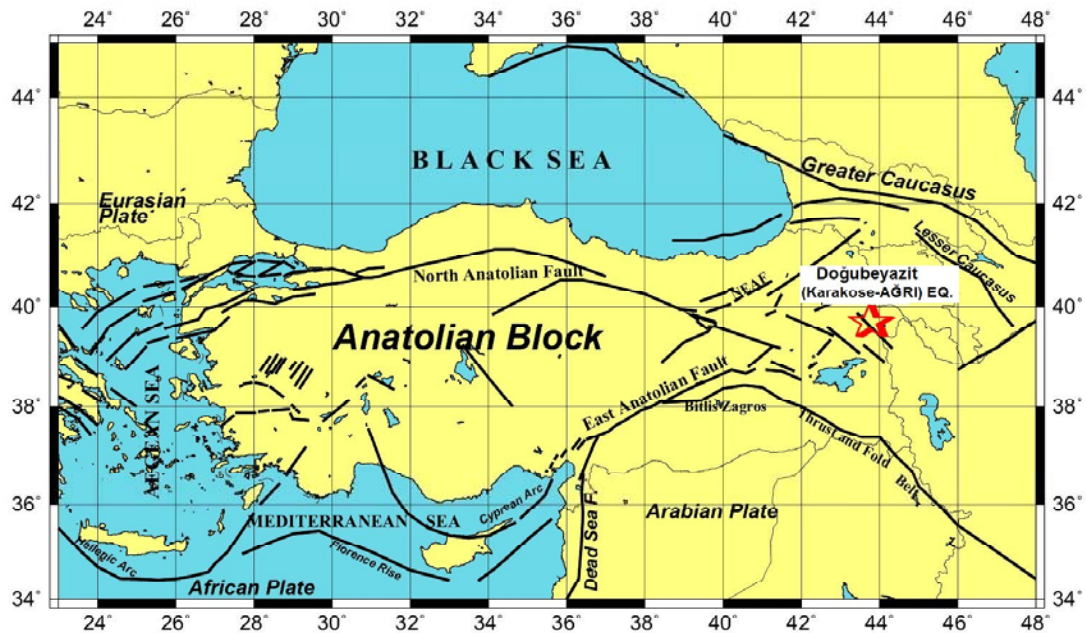
Major tectonic entities of the Turkey surrounding area

Generally, the tectonics of the region are controlled by the collision of the Arabian and Eurasian Plates.

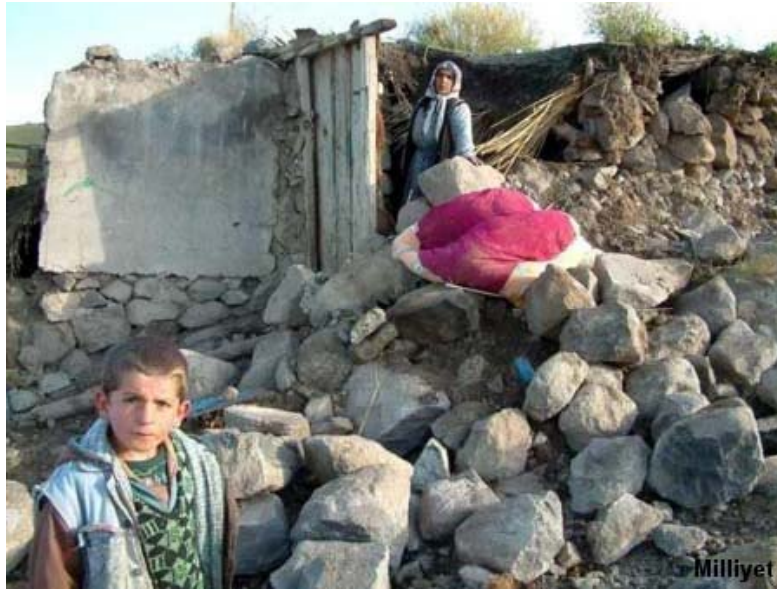
The epicenter of the earthquake was in the Yığınçal village. This earthquake caused the destruction of practically all the traditional houses of the villages in Yığınçalı-Sağlıksuyu and surrounding 15 villages. Due of the hot weather in the earthquake region, many people were living at plateaus that caused reducing the number of the deaths. The earthquake was felt at near cities and strongly in Yığınçalı village. Many houses were damaged in the Yiginçali where 17 people of 67 were killed because of the traditional houses are made of stones and himis-adobe. The damage was occurred in the other villages in the region but no people were killed, about 35 people injured there. Near the epicentral area, namely the villages of Kutlubulak and Sağlıksuyu where only 4 people were injured due to many people were living in tents at plateaus during this earthquake.

Himis type structures collapsed over 15 village

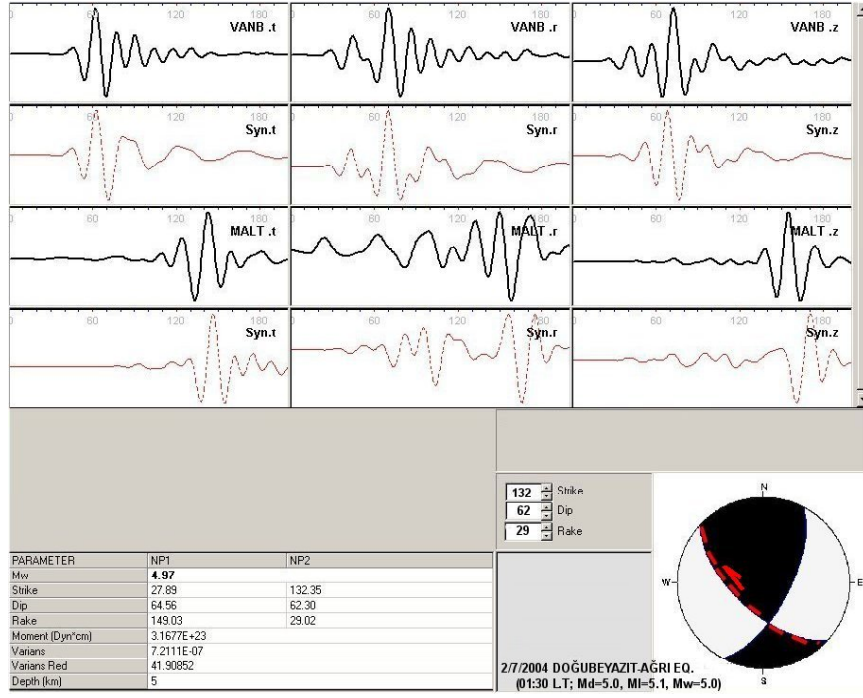
Focal Mechanism Solution

The fault plane solution of the earthquake was calculated from digital broadband stations in three components. According to the this analysis, 02 July 2004 Doğubayazıt earthquake shows the left-lateral strike slip fault that has a reverse component. The original and calculated synthetic waveforms with a moment magnitude are seen the below figure.
